Bicyclist Safety on Grooved Thermoplastic Edge Lines

Pictures and report submitted by
Tom Evans, 1/16/11
Bike Walk Tennessee

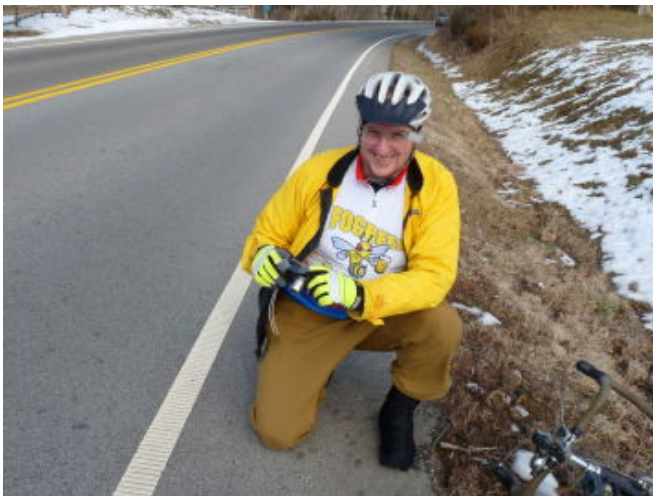
On 1/15/11 Bruce Day (shown in picture to the left) and Tom Evans rode this test strip on road bikes with 700-25mm tires to ascertain its impact on bicycle traffic. The road temperature was estimated to be about 36-degrees F.

They rode on the strip, along the strip, and criss-crossed it numerous times. Although the treatment can be felt by the bicyclist, it caused minimal discomfort and presented no safety issues. The results were summarized by Bruce below.

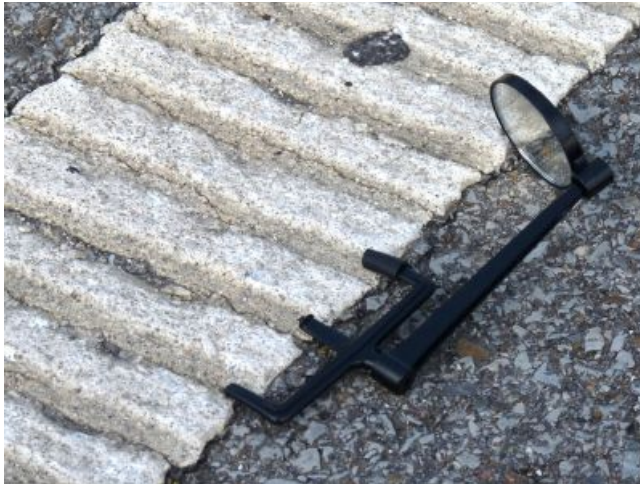
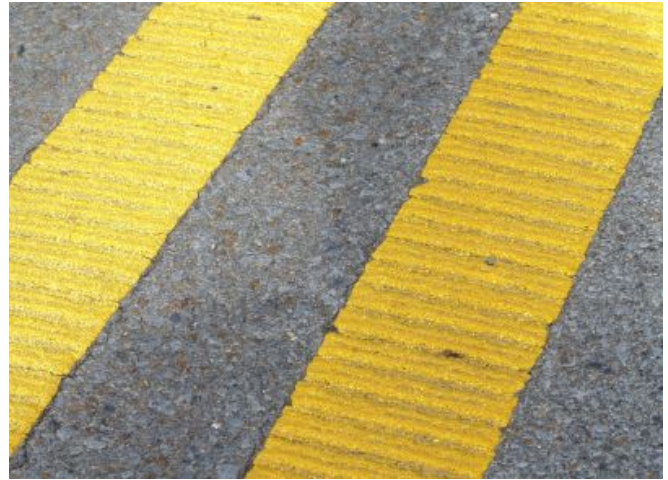
The strips on Carters Creek are absolutely no problem for cyclists. Tom and I rode the entire stretch weaving over and back across the strips several times and riding right on the strip as long as we could hold a line. There was the slightest vibration transmitted while on the strip and

no sensation whatsoever during the transition. It would appear these have been down a while. Newly applied strips might be more of a problem for a while but I can't imagine they would be appreciably different from the standard smooth strips which can be slick when wet. That is just part of road riding. I road my skinny tired bike today.

One picture shows the center lines are also corrugated. I didn't notice till reviewing my images at home and did not feel a thing when crossing them to turn onto Southall Road.
